Subsidence at the “Trébol” of Quito, Ecuador: an indicator for future disasters?

T. Toulkeridis¹, D. Simón Baile¹, F. Rodríguez¹, R. Salazar Martínez¹, N. Arias Jiménez², and
D. Carreon Freyre³

Published: 12 November 2015

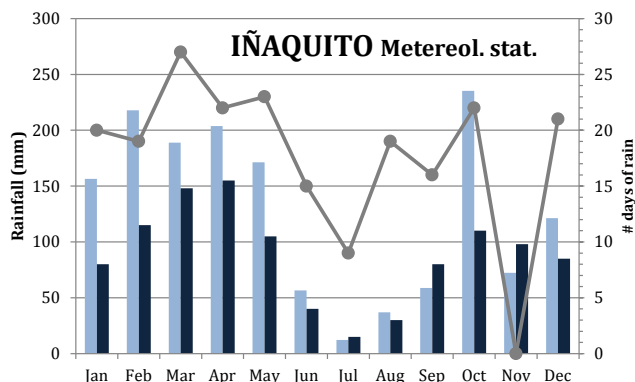
**Figure 1.** Total monthly rainfall, average multiannual rainfall (of the available data) number of days with rain per month (higher than 0.1 mm) of the closest meteorological station to El Trébol being Iñaquito. From National Institute of Meteorology and Hydrology (2010).

Regarding rainfall, the distribution along the year shows the prevalence of two periods with abundant rainfall being these, February–May and October–November respectively, (EMAAP-Q, 2006; Table 1, Fig. 1). On the other hand, as for the multiannual distribution of rainfall it is important to highlight that the wet season between January and March 2008 was considered the strongest of the last 20 years with accumulated rainfall during the first 3 months of 2008 being much higher than the recorded during any other heavy rainy seasons

of 1989, 1993 and 2000 (Salazar et al., 2009). In particular, a peak of 21.2 L m^{-2} was registered on 31 March 2008 during a heavy rainfall that lasted 4 h from 1 to 5 p.m. (INAMHI, 2008; El Comercio, 2008; Salazar et al., 2009). Furthermore, within the whole year 2008 and coinciding in the three meteorological stations closest to “El Trébol”, March recorded continuous raining since it was the month with the highest number of days of rain, with 27 and 29 out of 31 days in Iñaquito and Izobamba respectively (Fig. 1.)

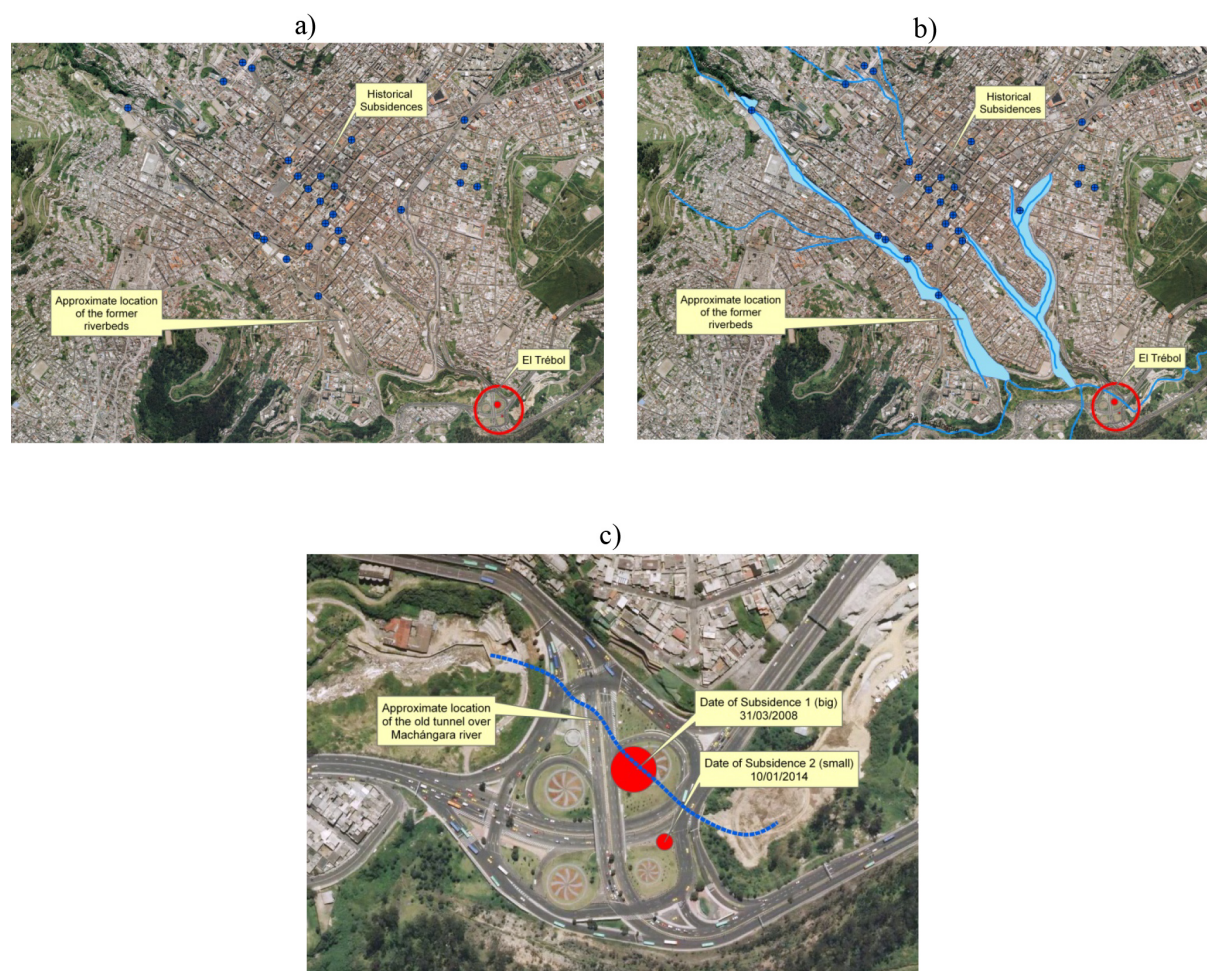
As a result of uncontrolled growth of the city, this natural drainage system was conducted on sewer channels below the construction of roads for vehicular traffic, and historically have been recorded 12 sinkholes (Fig. 2a) of different magnitudes, defined as “declines or collapses of roadway in the filler material streams, caused by faulty sewers”. The responsibility gets under the fill type initially performed with debris and garbage, as well as the age, type of construction and degree of deterioration of the physical work of the channels, sewers and collectors (Pewter, 1986; Fig. 2b). The location of these sinkholes is defined about the old bed of the streams filled so we can assume that on its way continue to occur, especially in periods of daily rainfall above the historical average. In the area of EL Trébol, the first serious collapse was registered on 31 March 2008 and took ten years after the river and fill channels were made for the construction of the infrastructure to solve the problems of the traffic jams. There was a second sink lower rates on 10 January 2014 (Fig. 2c).

Figure 2. (a–c) Historical subsidences at Machángara river, El Trébol sector.

As result of this event, we consider as a priority to take corresponding actions to prevent future collapses. Taking in consideration the alignment of the actual and past sinkholes, these alignments need to be reinforced in order to avoid future disasters in that area. As demonstrated in our study, the real costs of damages are much higher in the indirect damage of such sinkhole events rather in the reconstruction of the disaster site itself. Unfortunately, the enforcement of the potential subsidence areas did not take place yet, as demonstrated by a new sinkhole in 2014 in a zone where the vulnerability has been previously emphasized.
