# A reanalysis of the collapse of the Heidegroeve: subsidence over an abandoned room and pillar mine due to previously unknown mine workings underneath

Roland Frits Bekendam

GeoControl, Maastricht, 6226 WG, the Netherlands

Published: 22 April 2020

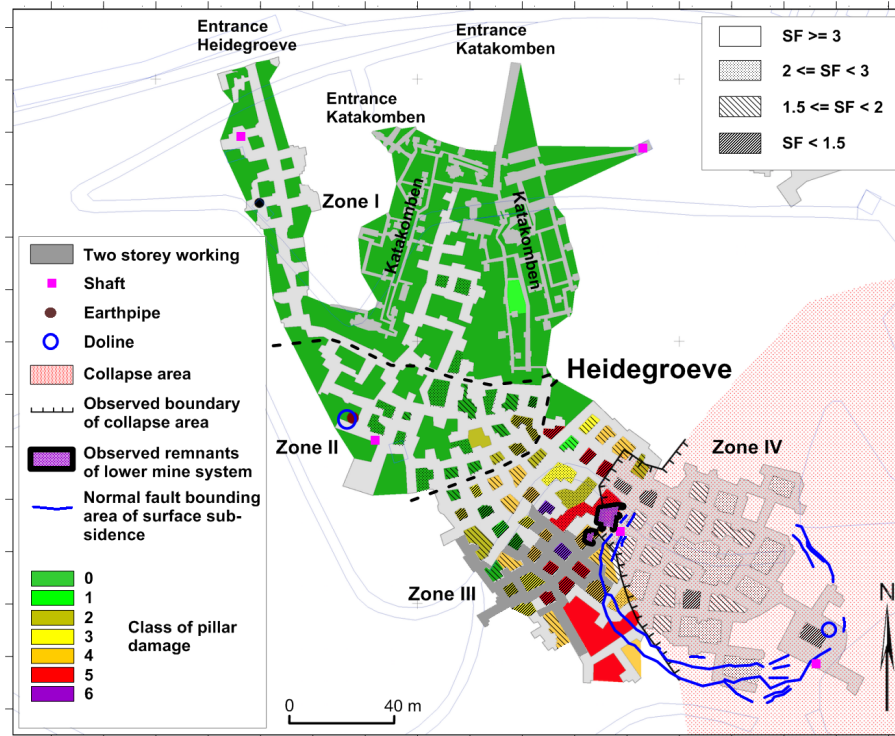
**Figure 2.** Map of the Heidegroeve.

Most pillars are more or less rectangular with horizontal dimensions of 4 to 12 m. Their height is about 2 m in the major part of the mine, but in the central part an additional 2.6 m of the overlying strata was extracted (Fig. 2). The galleries are usually 3.5 to 4 m wide. Joints rarely occur.

At the surface an elliptical subsidence area of about 100 m by 70 m, bounded by normal faults, had developed (Fig. 2). A restaurant, just 30 m to the south of the subsidence area, was fortunately undamaged. The outer normal faults showed apertures of up to 40 cm and downward displacements of up to 80 cm towards the subsidence area. These faults were often accompanied by more or less parallel antithetic faults with less apertures and downward displacements, resulting in a graben-like structure. A fence, situated inside the collapse area, was damaged and underwent horizontal shortening of about 10 cm. Close to the easternmost shaft a doline of about 1.5 m depth had developed.

In 2010 and 2012 new surveys of the Heidegroeve were carried out (Bekendam, 2012) concerning the safety of tourists in the Katakomben and bat researchers in the Heidegroeve. All pillars were classified again, but now in more detail according to the system of 7 classes (Fig. 2). In the northwestern part (zones I and II) hardly any pillar damage has developed, but in zone III, adjacent to the collapse area, the majority of pillars are affected by serious cracking and spalling (class 4–6). Often the brick cladding had parted from the pillar walls and fallen on the floor. The pillars in the collapse area are to be characterized as class 7 by definition, but this is not indicated in Fig. 2 to keep the map organized.

Also the pillar safety factors were recalculated using Eq. (1), with a UCS of 2.0 MPa and densities of the limestone and the overlying soil of  $1.6 \times 10^3$  and  $2.0 \times 10^3 \text{ kg m}^{-3}$  respectively. In Fig. 6 pillar stress and pillar strength are depicted for zones II–III and zone IV separately. For zones II and III all more or less intact pillars (class 0 and 1) except four have safety factors exceeding 1.5. Most pillars with moderate damage (class 2 and 3) have safety factors of less than 2 except two cases, and the majority of seriously damaged pillars (class 4–6) have safety factors of less than 1.5, except for nine cases. So far the relationship between pillar class and safety factor is as to be expected. However, nearly all class 7 pillars of the collapse area (zone IV), 26 of the total 30 pillars in the area, have safety factors of more than 1.5. Just 4 pillars show a safety factor of less than 1.5. These safety factors are abnormally high for a collapsed area. The safety factors are indicated in Fig. 2 as well.

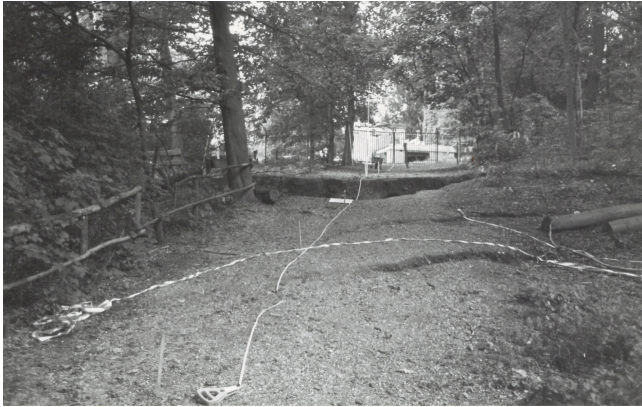
**Figure 3.** Normal faults on the footpath just north of the restaurant in the background (Courtesy of David George Price).

In the evening of June 1988 walkers in the Polferbos observed cracks in the footpaths and raised the alarm (Fig. 3). An examination of the mine showed that 0.4 ha in the south-eastern part of the mine had collapsed. The collapse was recorded by seismographs in the region. The shock lasted less than 45 s with about 10 s of strong motion. The subsidence at the surface and the pillar damage underground are described by Price (1989).

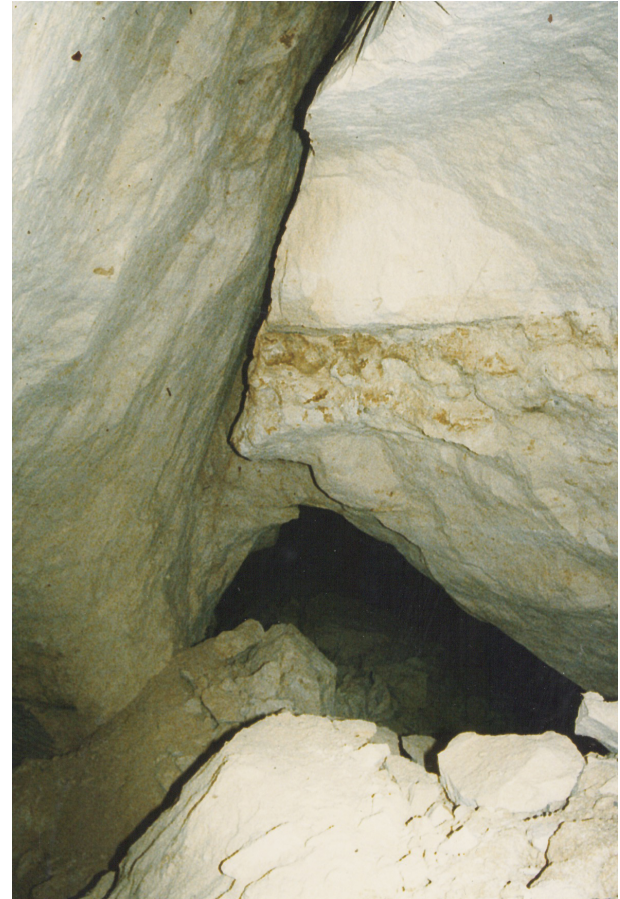
**Figure 4.** Collapse-induced fault in the rock overburden of the Heidegroeve.

gated (Bekendam, 1998). The limestone overburden proved to be subsided along faults dipping at an angle of 65 to 80° towards the not-collapsed part of the mine (Fig. 4). Thus, the collapse is obviously of Type A. At the basis of the faults often roof falls had occurred resulting in arches up to 8 m above the original mine roof. Below the arches debris piles reached levels mostly exceeding that of the original mine roof. From the top of the debris piles the faults could be observed up to more than 10 m above the original roof, and the fault orientation seemed to be unchanged as far as could be seen. There is no infill of soil, probably to the considerable thickness of the rock overburden. The fault showed an opening of several decimetres, which is a logical consequence of the collapse geometry. A remarkable feature is that an open fault proved to be present in the mine floor, near the bunker shaft at the boundary of the collapse.

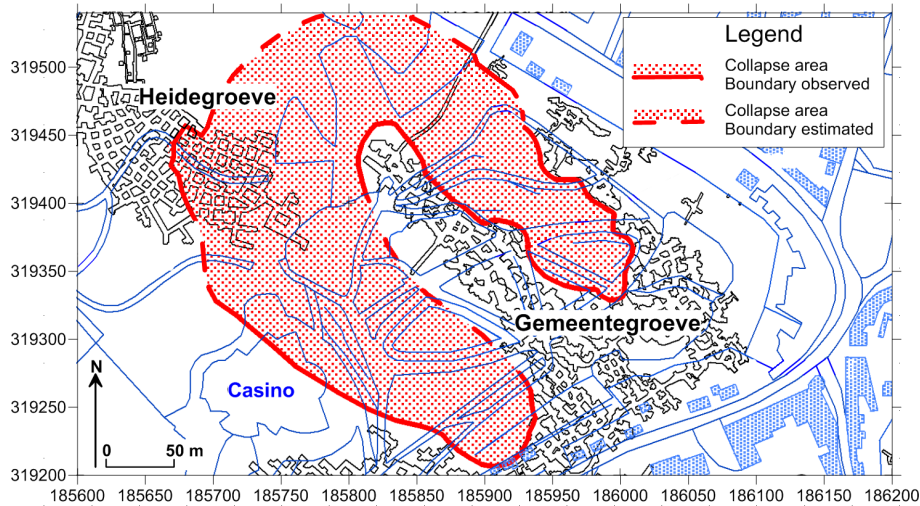
**Figure 5.** The collapse area between the Heidegroeve and the Gemeentegroeve.

2. Between the Heidegroeve and the northwestern part of the nearby Gemeentegrot an extensive collapse area exists, comprising unmapped and inaccessible, more or less intact workings (Fig. 5). More than 200 borings for a site investigation for the erection of a new casino showed both collapsed- and not-collapsed (but possibly damaged) mine workings in this area. The Gemeentegrot and the mine workings at its perimeter were excavated in the Limestone of Nekum, which is about 5 m below the Limestone of Meerssen of the Heidegroeve (Felder, 1979).
3. The observed open fault in the mine floor could only have developed if open space was present at a lower level.

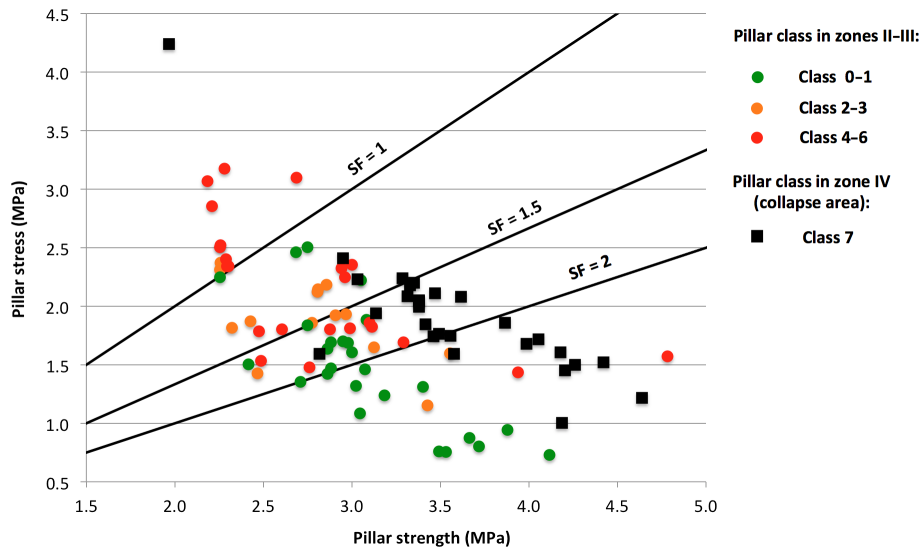
Moreover, the total safety factor of the pillars inside the collapsed area of zone IV proved to be 2.52. A collapse of an area with such a high safety factor is normally impossible. The still standing zone III shows a much lower total safety factor of just 1.76. This value represents dubious large-scale pillar stability. The total safety factor of the more or less undamaged zone II is 2.92.

**Figure 6.** Pillar stress and pillar strength for pillars of different pillar classes in zones II–III and zone IV.

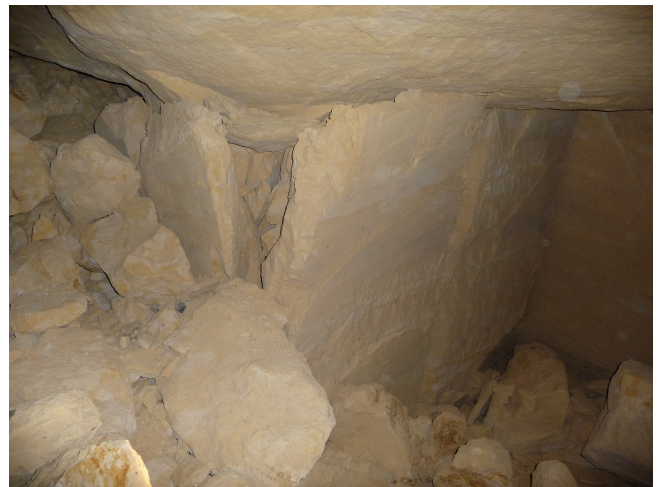
wall of the fault. At about 3.5 m below the floor of the Heidegroeve two small chambers were discovered (Fig. 7). Indeed, the presence of a lower mine system was now proven! The southwestern chamber is just 2 by 4 m, and is bounded in the east by the debris-covered fault and at the other three sides by more or less intact walls. The larger northeastern one measures about 12 m<sup>2</sup>. The walls of this chamber are largely fractured and spalled (class 5–7). The northeastern chamber is not only limited by debris in the south, near the fault, but also at its northeastern side. Both chambers are about 2 m high and contain saw- and chisel marks from exploitation, which dates from the 17th or 18th century (Wiel Felder, personal communication, 2012). The debris blocks off any passage to possible openings further inside the collapse area at the lower mine level.

**Figure 7.** Collapsed pillar in the northeastern chamber of the lower mine system. The debris slope to the left gives access to this mine level.

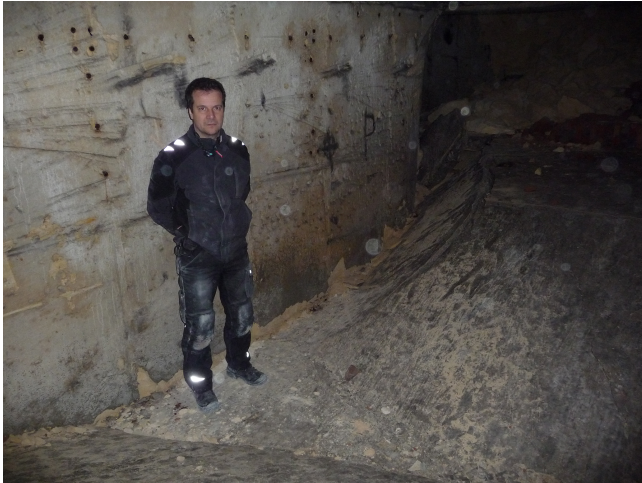
ferences of about one metre (Fig. 8). This interesting phenomenon was most probably brought about by punching of pillars of the lower mine.

**Figure 8.** The strongly tilted mine floor in the collapse area of the Heidegroeve.

ing. This fault was not present in the mine floor of the Heidegroeve before the collapse of 1988. This means that the lower mine working collapsed together with the Heidegroeve. The strongly tilted parts of the mine floor inside the collapse area of the Heidegroeve show that pillars of the lower mine system had punched through the about 3.5 m thick interlayers. On the other hand, pillars of the Heidegroeve have probably punched through the interlayers inside galleries below. It is unavoidable that pillars of the Heidegroeve have been created above galleries of the lower mine and vice versa. The pillar deterioration in zone III preceding the collapse is probably due to an increase in pressure due to the abutment pressure of the lower working (Bekendam, 1998). Such a feature was also described by Kratsch (1997). About 50 years elapsed since the end of the exploitation of the Heidegroeve until creep deformation reached an accelerating stage giving rise to the collapse.
