## Application of seismic prospecting to determine the width of influence of surface faults associated to land subsidence – a case of study in the Aguascalientes Valley, México

**Abstract.** Aguascalientes valley, located in the central part of México, is affected for a land subsidence process triggered by groundwater withdrawal since the 1980's. Currently, the occurrence and the reactivation of surface faults and earth fissures due to differential subsidence, is the main concern for government bureaus dealing with urban planning, because of the damages that these terrain discontinuities are able to cause in constructions and infrastructure. The deformation and rupture process produces an active linear discontinuity with a variable width of influence, where the constructions and infrastructure are prone to get damage. Therefore, the determination of this width of influence is critical for urban planning and hazard determination.

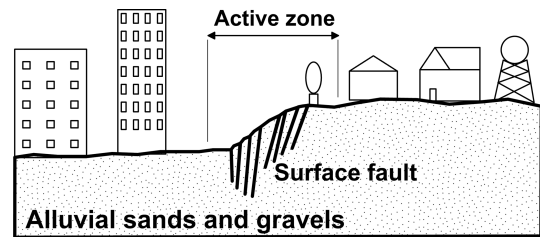
**Figure 1.** Scheme showing the active zone, which is the strip of mechanical disturbing caused by the main terrain discontinuity, where buildings and infrastructure can suffer damaged by differential subsidence.

On the other hand, the stripe of the main terrain discontinuity, where buildings and infrastructure is damaged by differential settlements, has been named as affectation width of the fault (Figueroa-Miranda et al., 2018), influence zone of the fault (Avila-Olivera and Garduño-Monroy, 2008), fault zone width (Hernández-Marín and Burbey, 2009) and active zone of the fault (Pacheco-Martínez et al., 2015) (Fig. 1).

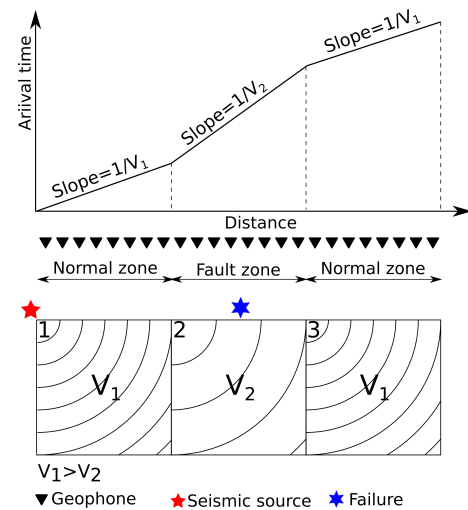
**Figure 5.** Conceptual sketch of propagation of direct seismic waves through a ground discontinuity.

Hence, the decrease in the velocity of propagation of the seismic wave can be related to a density decrease of the material adjacent to the discontinuity, caused by the generation of secondary fractures and microfractures as the discontinuity causes soil deformation. Figure 5 shows a conceptual scheme of the change in the seismic wave propagation velocity due to the presence of a ground discontinuity. The figure shows that the waves propagate through block 1 with a velocity  $V_1$ ; and then to  $V_2$  in block 2 (disturbed zone), and then returning to  $V_1$  in block 3. In this diagram, block 2 represent the disturbed zone, therefore,  $V_2$  is lower than  $V_1$ .
