More room for water

M. BRILLY

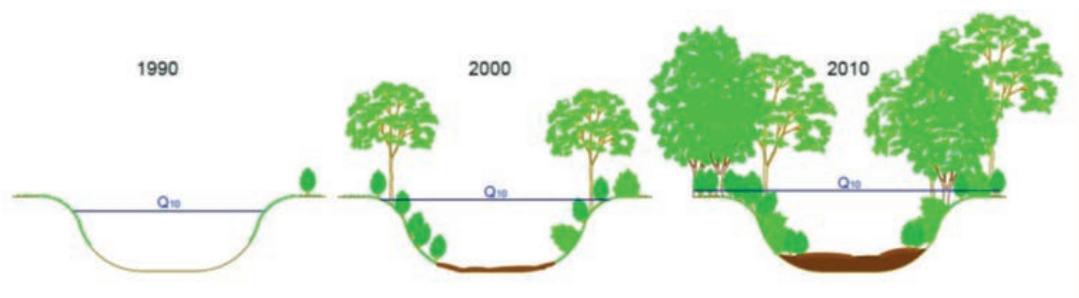
Fig. 1 Consequence of overgrowing vegetation.

Twenty years ago the maintenance of embankments of regulated natural watercourses was brought to a halt, and the new practice was seen as eco-friendly maintenance of watercourses. Many river banks were overgrown with bushes and the space for water was only further reduced. In some places, the vegetation in the narrow channels completely obscured the surface of the water (Fig. 1). The serious damages due to the recent floods and, last but not least, fatalities, are the price that we pay today; examples are the floods of the Gradaščica and Vipava River in 2010. To make matters worse, the pressure on the water land is increasing in urban areas. A particular problem is the culverting of streams for urban purposes. It is ecologically extremely inappropriate; open water disappears from the environment in which it can only be enriched. Channels are diverted and small streams are put in culverts, despite the requirements of the Water Framework Directive. Water land which was often flooded is now occupied by roadways and parking lots.

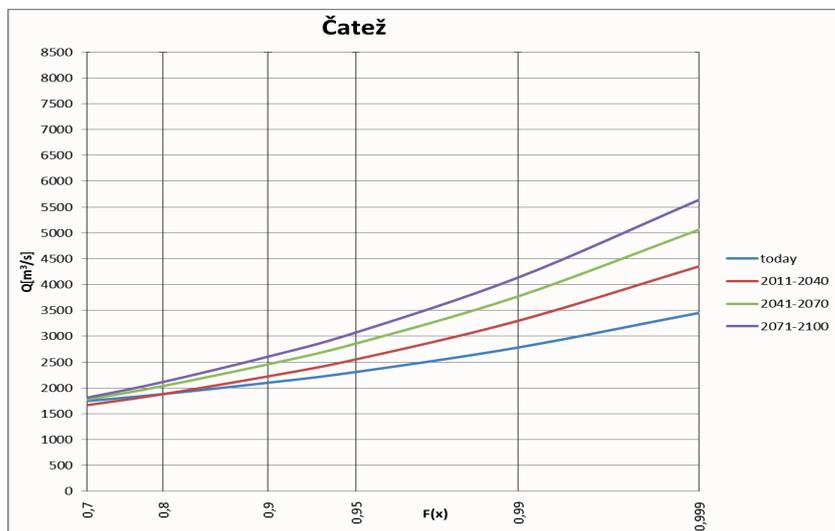
Fig. 2 Climate change impacts on probability curves of Water Station Čatež on the Sava River.

This situation will be further aggravated by the expected impact of climate change. The study prepared for the Sava River Basin Commission revealed that the 100-year return period discharges will increase to 10-year return period discharges until the end of this century (Brilly *et al.* 2014; Fig. 2).
