Tapped lakes as sediment traps in an Arctic delta

Abstract Lakes within the Colville River delta in northern Alaska, USA, vary in size from small ponds created by ice-wedge growth to thaw lakes that are as much as three kilometres long and ten metres deep. As the river migrates, lake edges are breached and the lakes are drained. Such lake tapping is aided by permafrost thaw and ice wedge melt and, in the case of the larger lakes, by wave action within them. Once a lake is tapped, it drains rapidly creating a deep scour hole at its entrance and from then on it is subject to the varying stages and discharge of the river. During flooding, when the river is transporting its largest amount of sediment, the tapped lakes become settling basins and rapidly fill. The Colville River delta has lakes in all stages from freshly breached to those that are now being destroyed by channel migration.

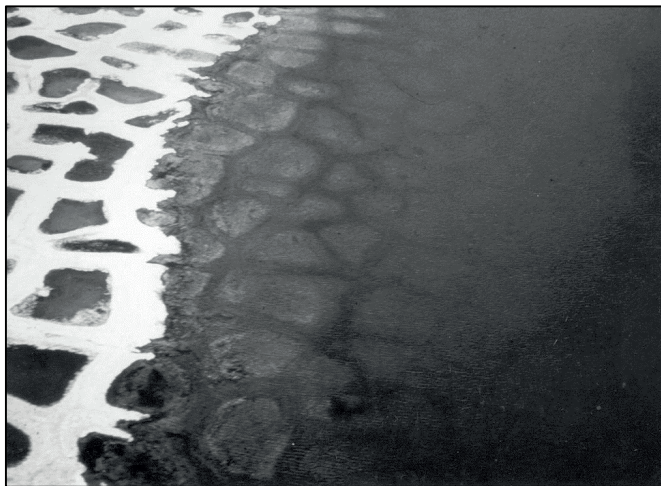
Fig. 2 Relief inversion due to ice wedge melt.

Most large lakes and many sections of the distributaries, especially those composed of peat, have banks that are bordered by ice-wedge polygons (Ritchie & Walker 1974). Ice wedges vary in width up to more than 2 m and in depth to more than 5 m. When exposed the ice is subject to melting and the frozen surrounding materials to thawing. Because the melt rate of ice wedges, especially those within banks of peat, is faster than permafrost's thaw rate, the bank line becomes serrated. Within the lake itself such retreat often results in an inversion of relief (Fig. 2).
